USAAEFA PROJECT NO. 76-03

C-12A LANDING GEAR CAPABILITY TESTS

FINAL REPORT

UNITED STATES ARMY AVIATION ENGINEERING FLIGHT ACTIVITY
EDWARDS AIR FORCE BASE, CALIFORNIA 93523

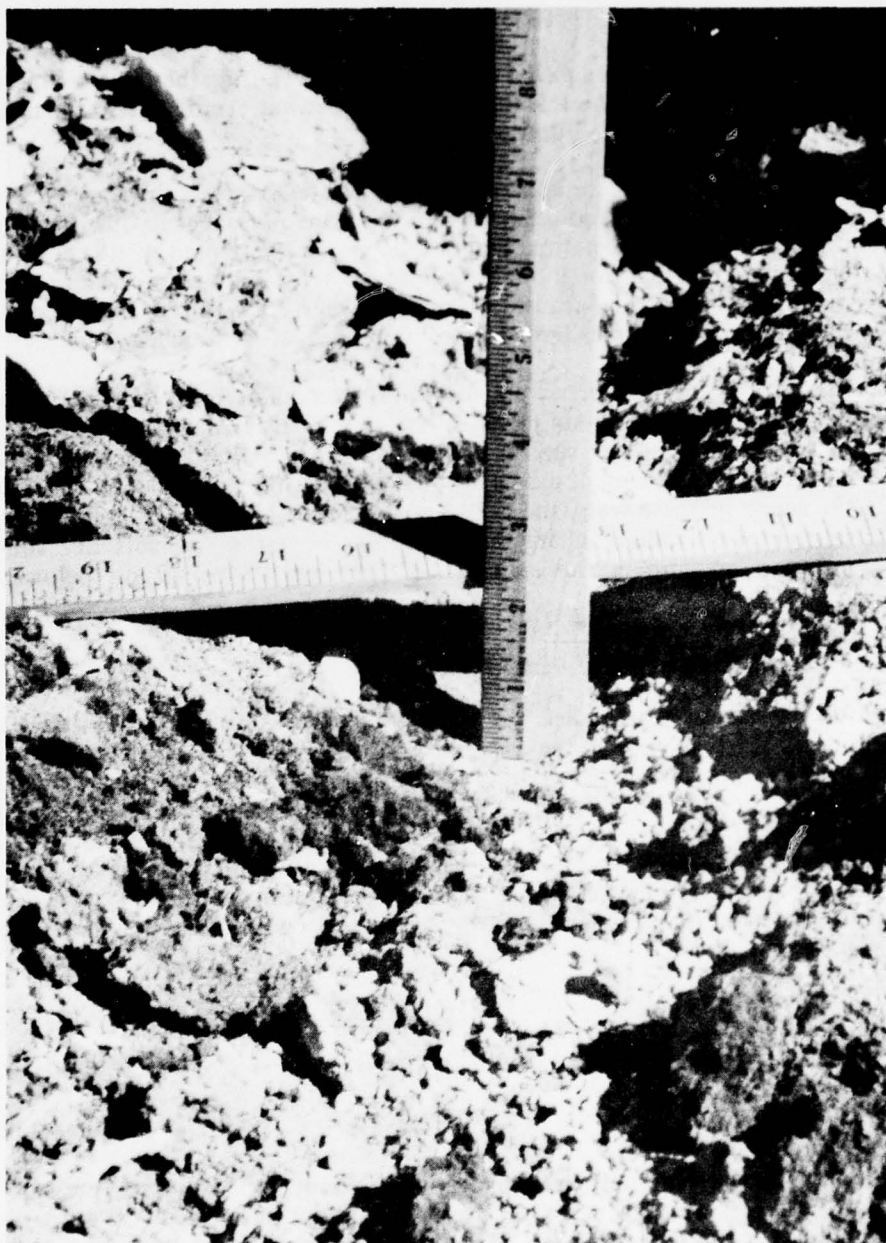
Photo A. Maximum Rut Depth.

11. A total of 40 passes were successfully completed with the maximum rut depth being approximately 2-1/4 inches (photo A). Additional rut depth data are tabulated in appendix D. After several passes were made, the topsoil had a tendency to compact and subsequent passes produced rut depths somewhat more shallow. Within the scope of these tests, the C-12A met the requirements of the PIDS and displayed satisfactory handling characteristics while operating on soft dry soil when the inflation pressure in the main wheel tires was 95 psi (7 psi below normal).

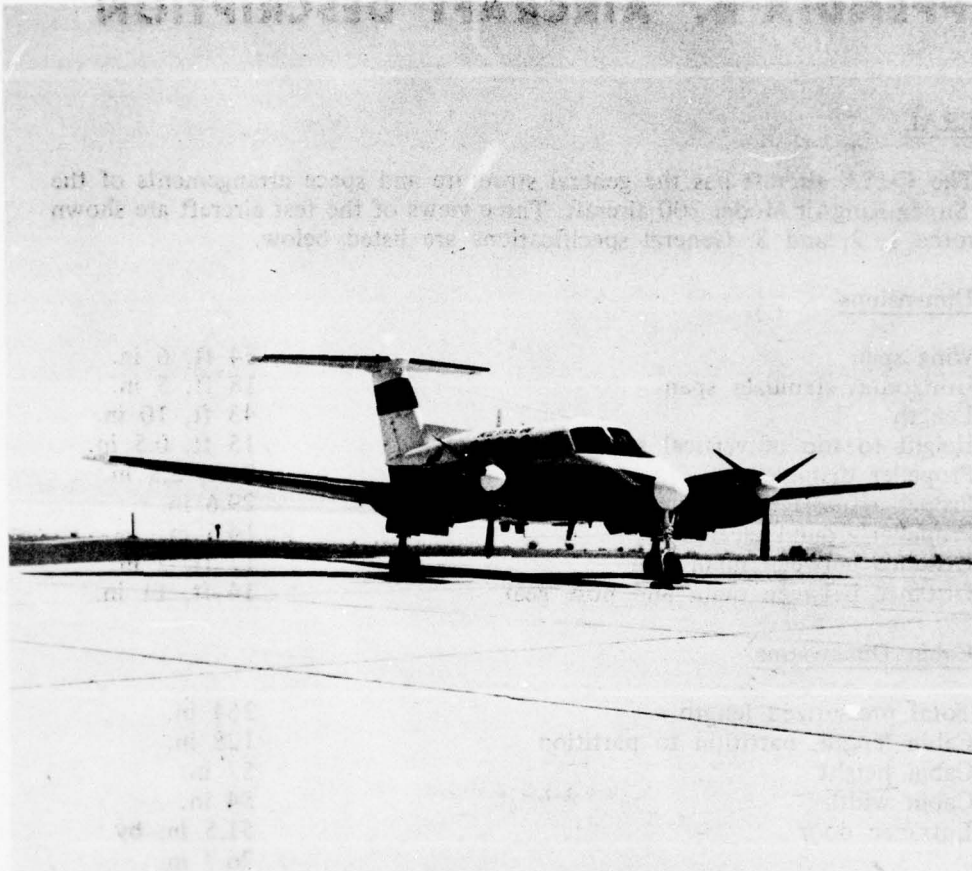
Photo 1. Right Quarter View.

1. The C-12A aircraft has the general structure and space arrangements of the BAC Super KingAir Model 200 aircraft. Three views of the test aircraft are shown in photos 1, 2, and 3. General specifications are listed below.
